EM17-002

September 6, 2017

## 2013 – 2017 PATHFINDER; RADIATOR SHROUD AND COOLING FAN ASSEMBLY REPLACEMENT PROCEDURE

**APPLIED VEHICLES:** 2013 – 2017 Pathfinder (R52)

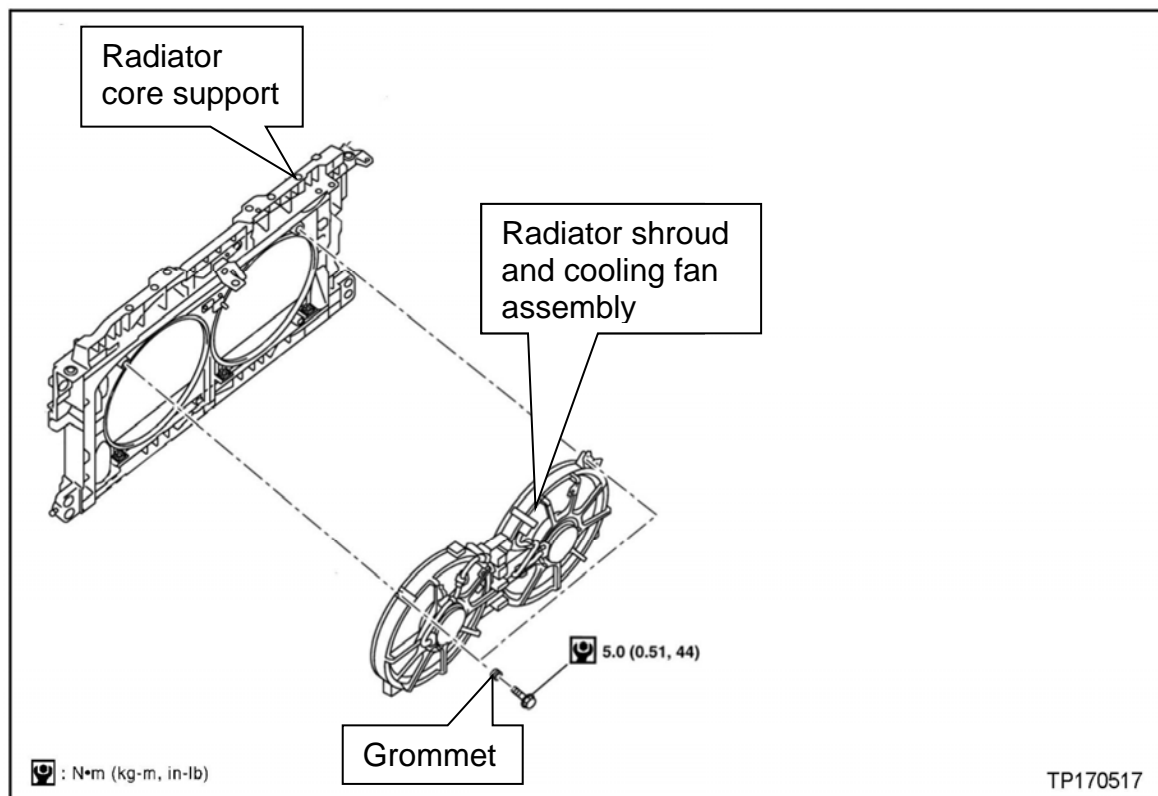
Figure 1

When replacing the radiator shroud and cooling fan assembly for any reason, the engine coolant, air cleaner case, and air duct does not need to be removed as part of the procedure. Use this SERVICE PROCEDURE (in place of the ESM) and the CLAIMS INFORMATION in this bulletin. The ESM will be updated at a later date.

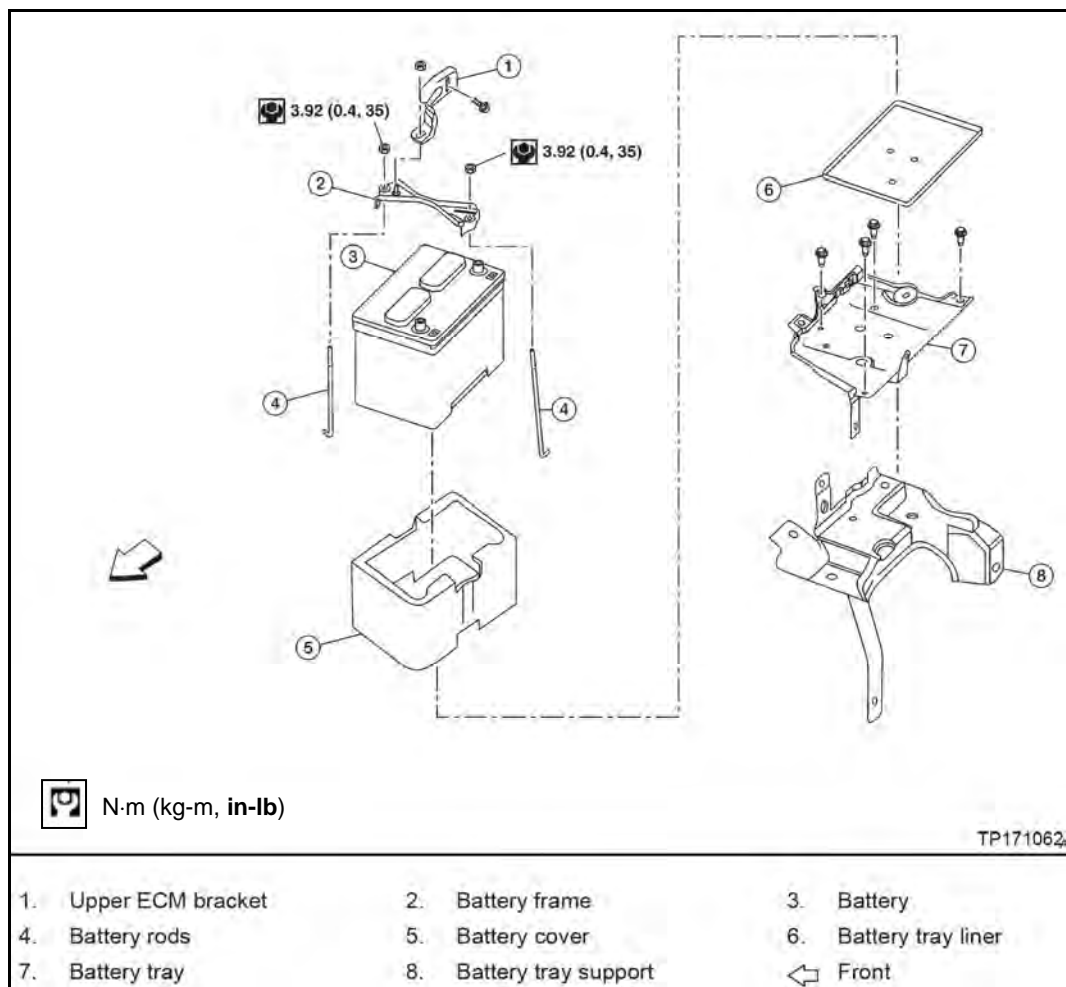
Figure 2

5. Disconnect battery negative terminal.
6. Remove cover on battery positive terminal.
7. Disconnect battery positive terminal.
8. Remove battery frame nuts.
9. Remove battery cover.
10. Remove battery.
11. Remove battery tray liner.

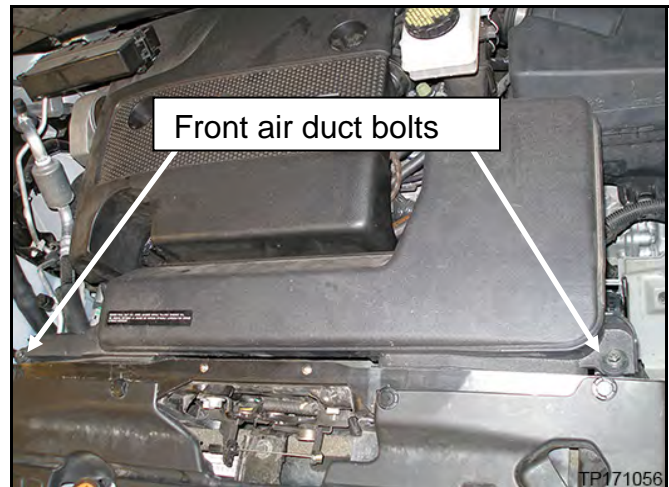
Figure 3

12. Remove 2 bolts securing the front air duct.

13. Remove the front air duct.

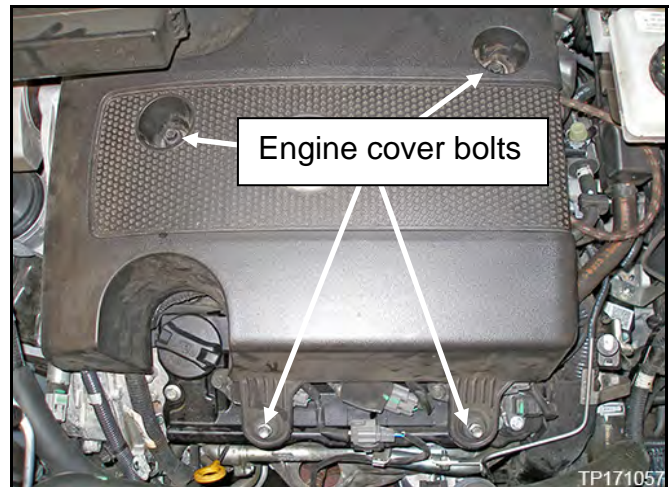
Figure 4

**NOTE:** Step 14 is for 2013 - 2016 model years only.

14. Remove 4 bolts securing the engine cover and remove the cover.

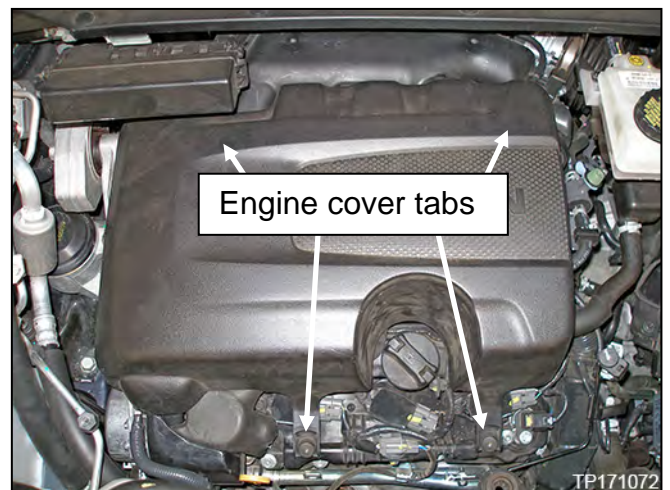
Figure 5

**NOTE:** Step 15 is for 2017 model year only.

15. Gently lift the engine cover to release the 4 tabs and remove the cover.

**NOTE:** The 2 rearward tabs are under the engine cover and cannot be seen.

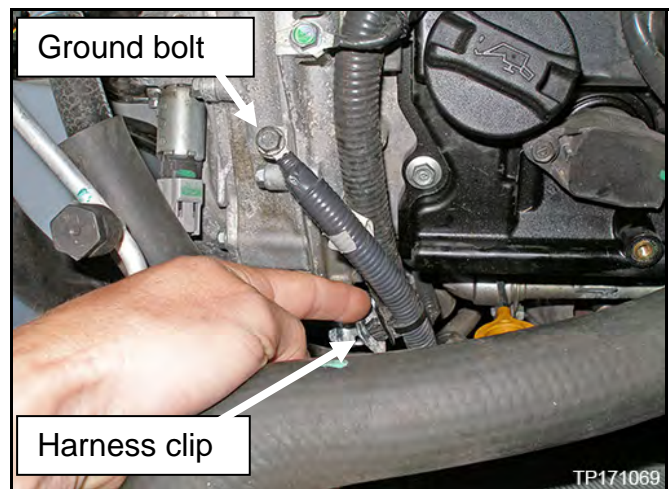
Figure 6

16. Remove ground bolt.

**NOTE:** 2013-2016 model years shown.  
2017 model year is similar.

17. Disconnect harness clip.

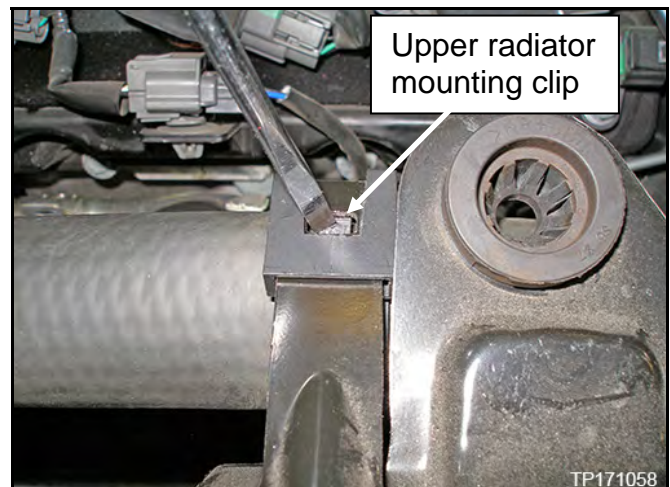
Figure 7

18. Disconnect clip securing upper radiator hose to radiator shroud.

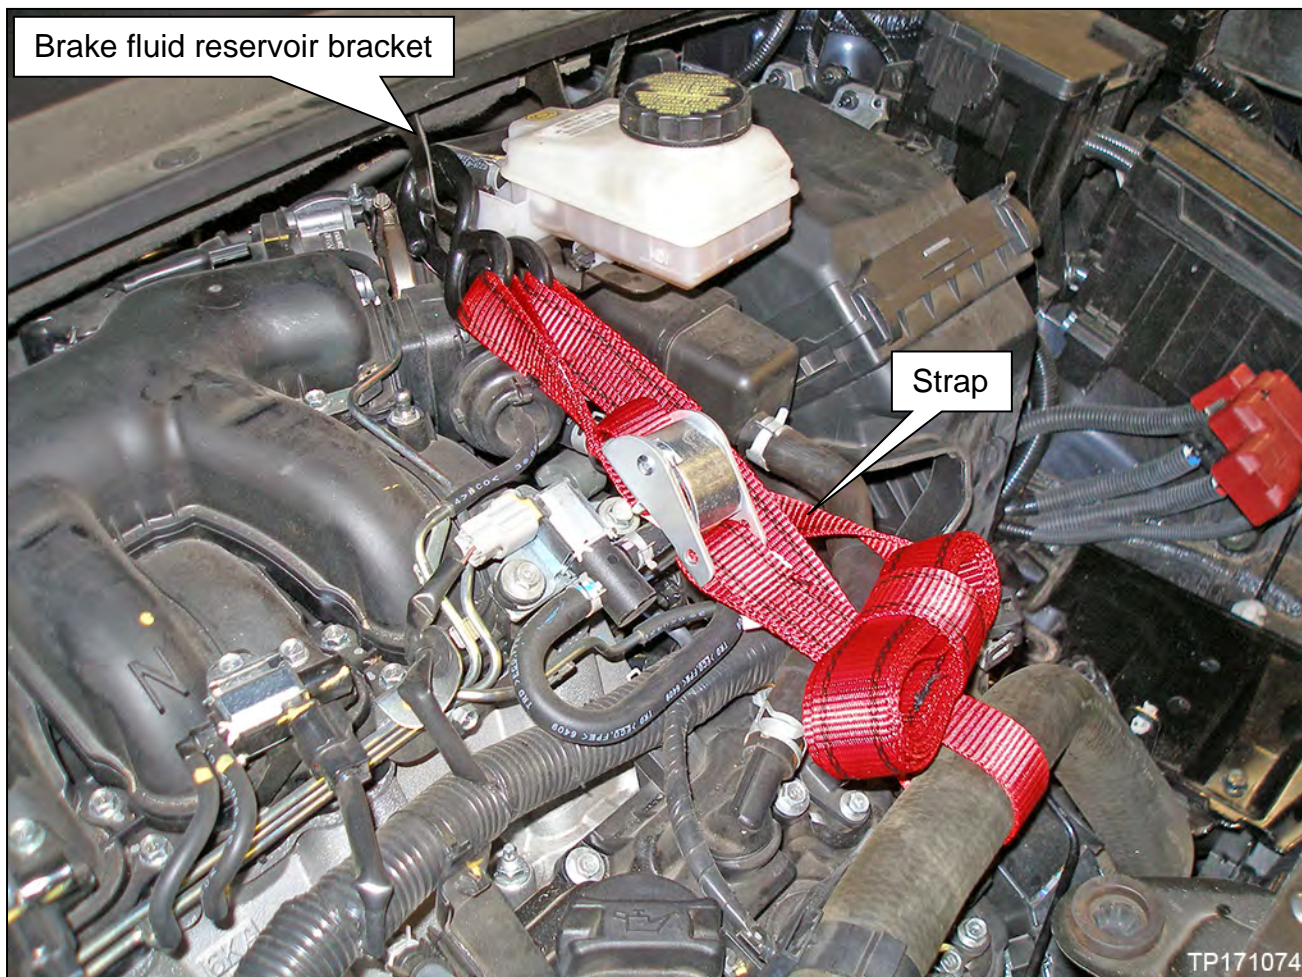
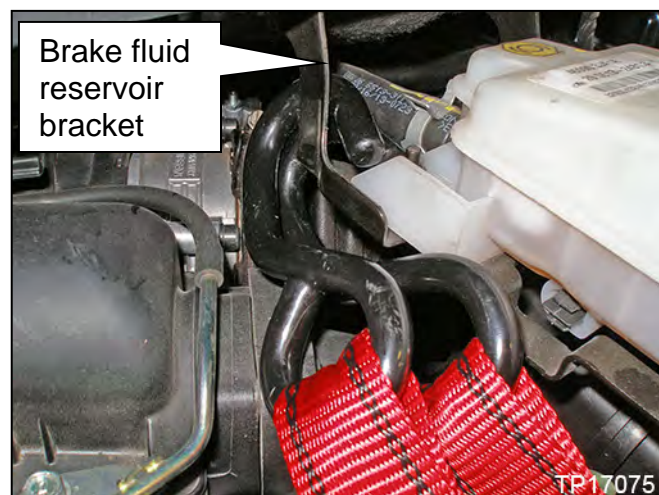
Figure 8

19. Temporarily secure upper radiator hose away from radiator shroud.

- Use a suitable strap to secure radiator hose.

**NOTE:** Secure the strap to the brake fluid reservoir bracket as shown in Figures 8 and 9.

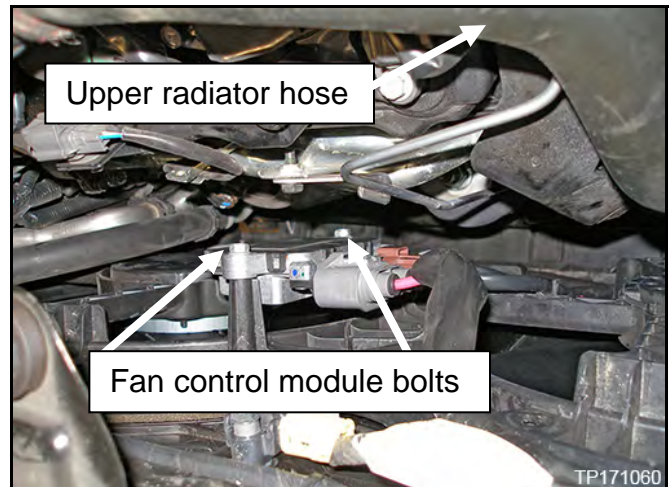
Figure 10

20. Remove the fan control module as follows;

- a. Disconnect the 3 electrical connectors on the fan control module.
- b. Remove the 2 bolts securing the fan control module to the radiator shroud.
- c. Remove the fan control module from the radiator shroud.

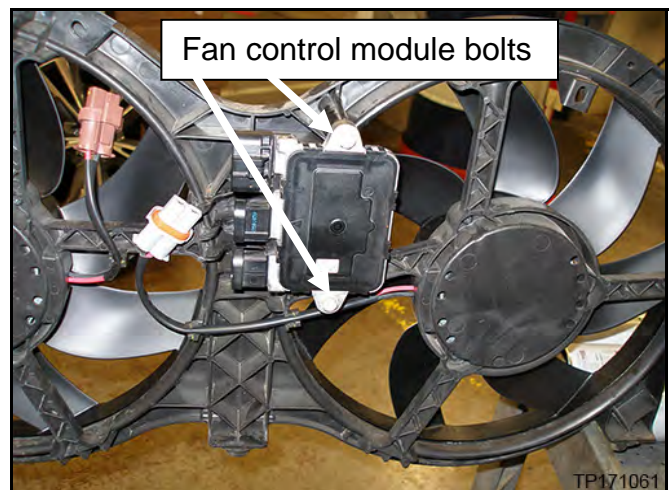
**NOTE:** Refer to Figure 11 for fan control module location (radiator shroud and cooling fan assembly removed from vehicle for clarification).

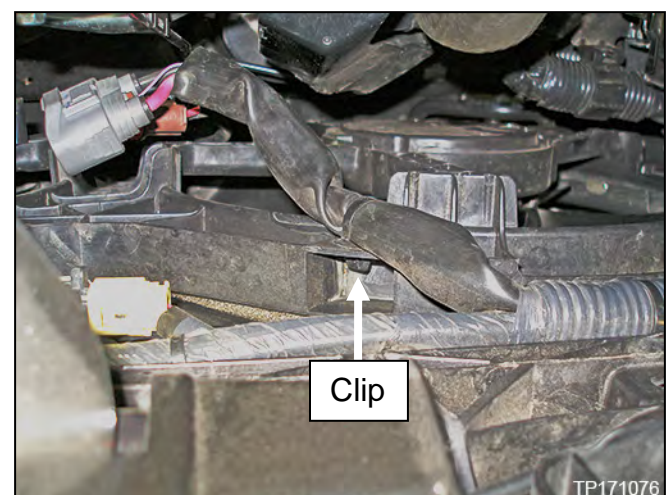
Figure 12

21. Release the fan control module harness clip from the radiator shroud and cooling fan assembly.

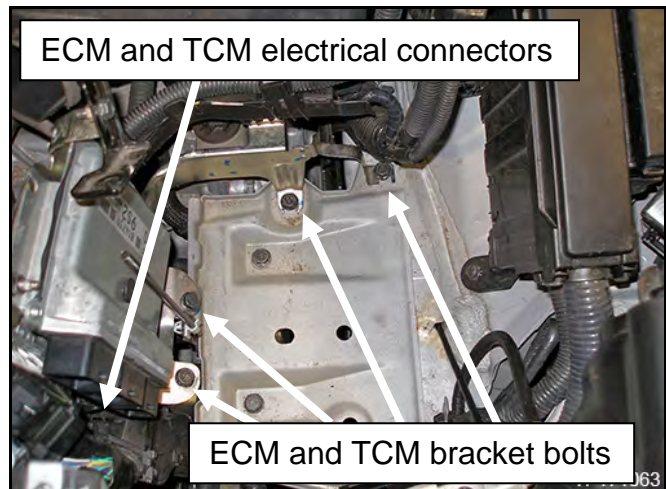
Figure 13

**NOTE:** Steps 22 and 23 are for 2013 - 2016 model years only.

22. Disconnect the ECM and TCM electrical connectors.

23. Remove the 4 ECM and TCM bracket bolts.

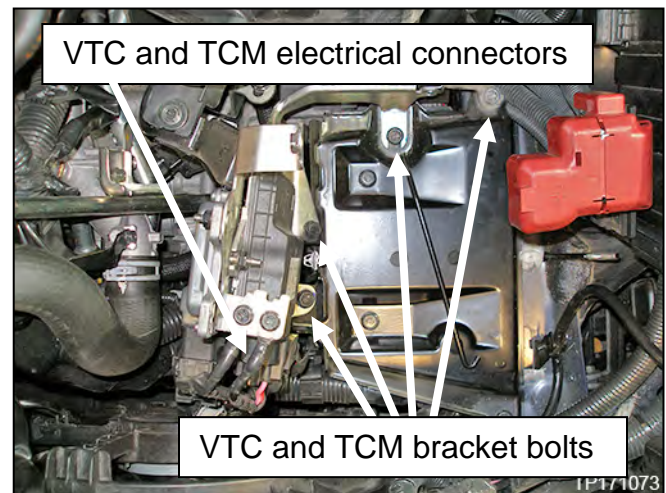
Figure 14

**NOTE:** Steps 24 and 25 are for 2017 model year only.

24. Disconnect the VTC module and TCM electrical connectors.

25. Remove the 4 VTC and TCM bracket bolts.

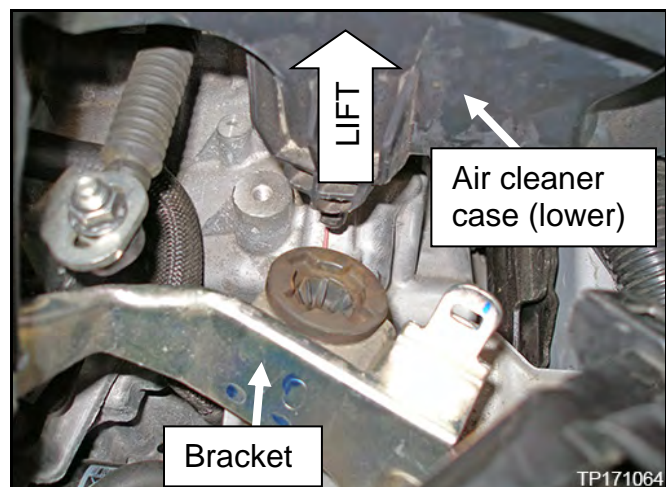
Figure 15

26. Lift up on air cleaner case (lower) to release the bracket.

**NOTE:** 2013-2016 model years shown. 2017 model year is similar.

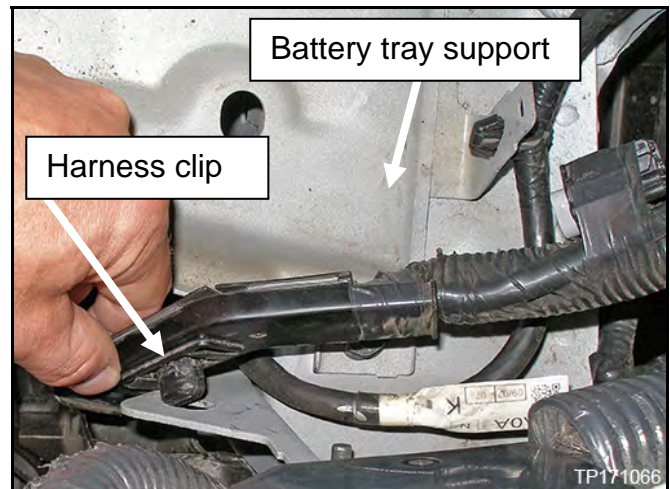
Figure 16

**NOTE:** Step 27 is for 2013 - 2016 model years only.

27. Release the driver's side harness clip from the battery tray support.

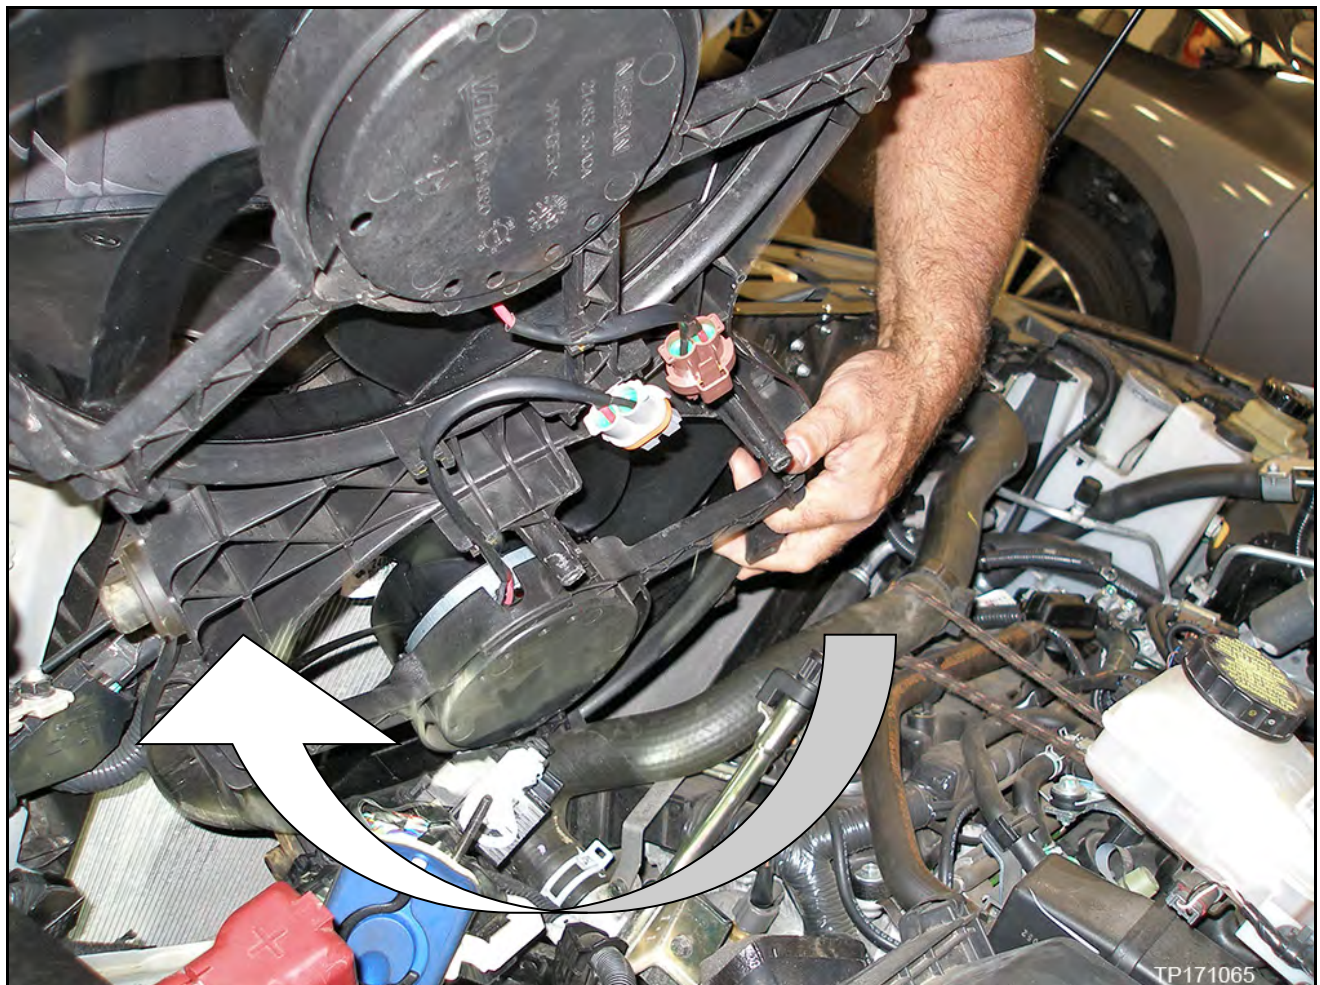
Figure 17

29. Remove the radiator shroud and cooling fan assembly.

- Start from driver's side and lift the assembly out of engine compartment.

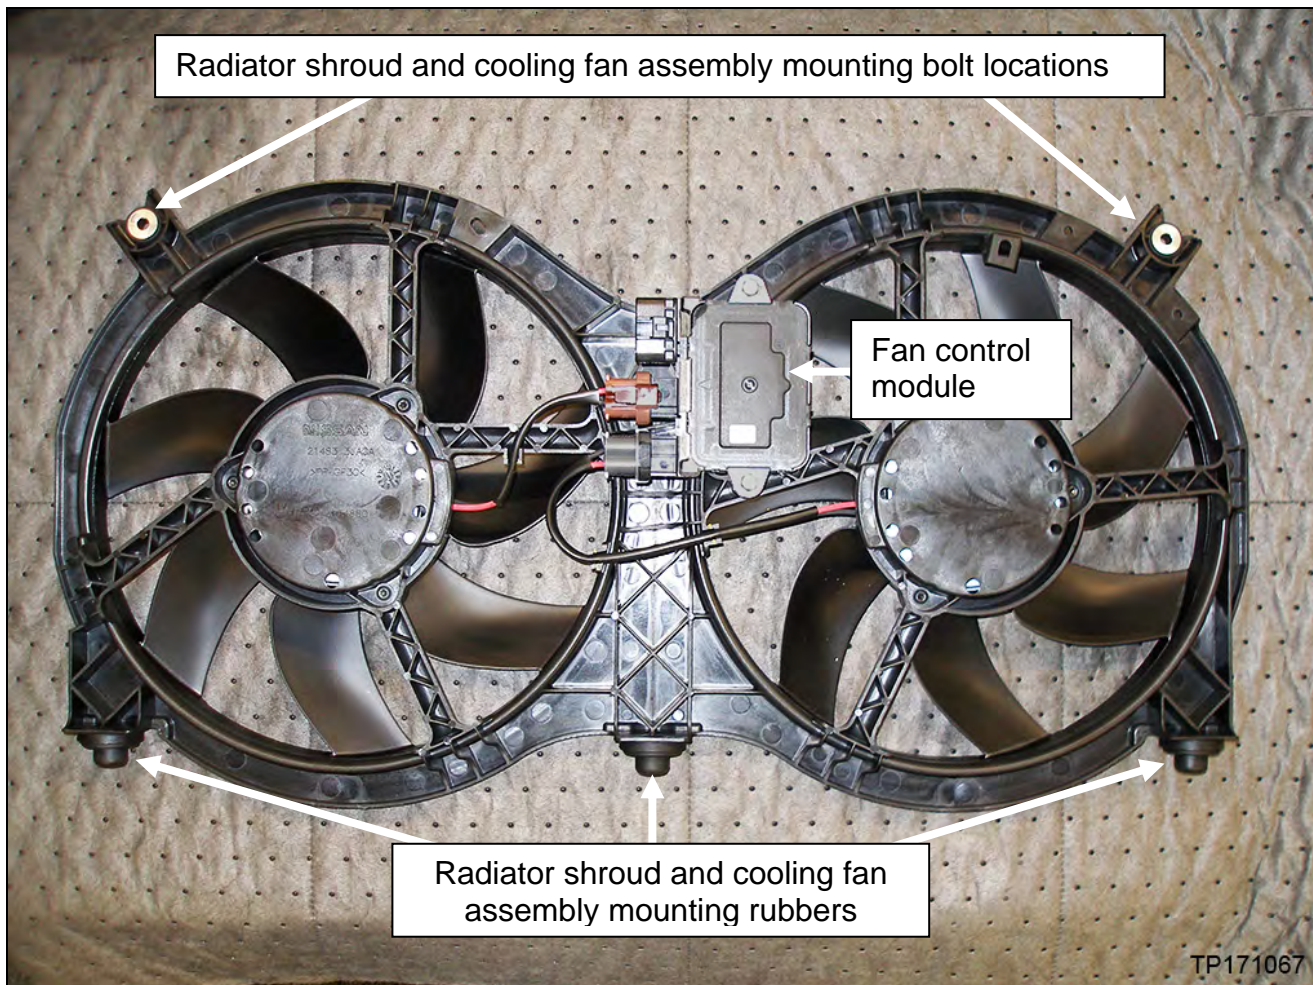
28. Remove the radiator shroud and cooling fan assembly mounting bolts (refer to Figure 18 on the next page for bolt location).
